TECHNICAL REPORT RL-76-13

2.75-INCH ROCKET LAUNCHER ICE PROTECTION
TESTS, DECEMBER 1975 TO FEBRUARY 1976

Donald Davis
Ground Equipment and Materials Directorate
US Army Missile Research, Development and Engineering Laboratory
US Army Missile Command
Redstone Arsenal, Alabama 35809

18 March 1976

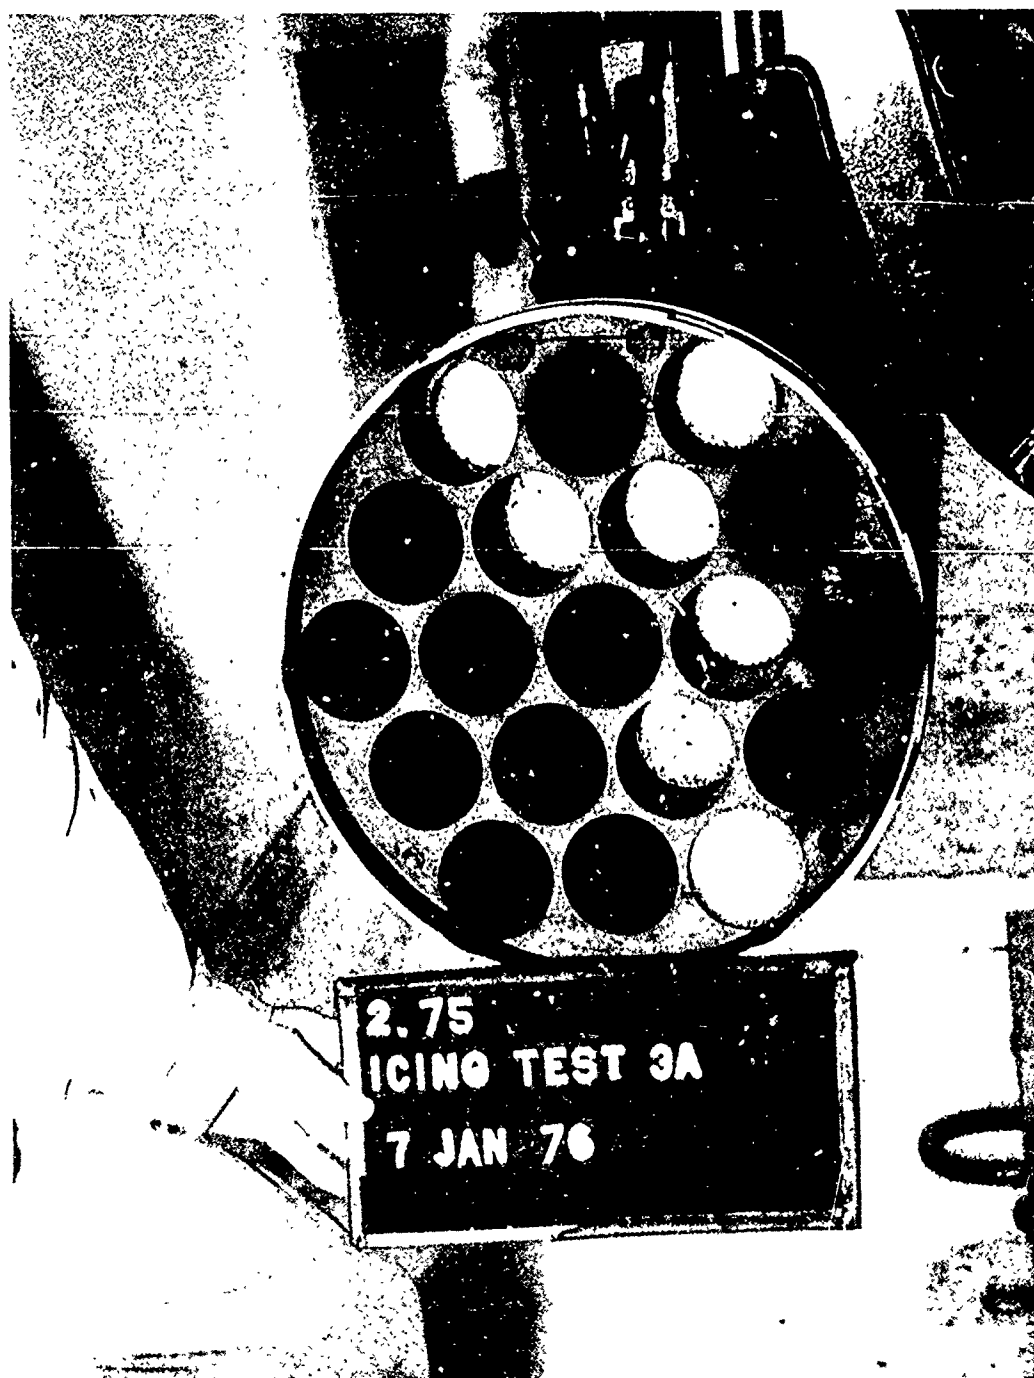
At firing, the plugs from the loaded tubes were shoved out ahead of the rockets. The plugs in the tubes loaded with inert rockets were shoved back until stopped by the fuze of the warhead (Figure 9). With the plugs now recessed in the tube, later icing could build up in front of the plugs. Although this condition was not tested, it is suspected that the launcher would be damaged if rockets were fired from this condition.

Figure 9. Launcher with plugs after firing, without ice.

Several methods to prevent the plugs from being pushed back were discussed, but never tested. Some of these methods were:

- 1) A shoulder made of a hard material, larger than the tube inside diameter.
- 2) A taper on the plug.
- 3) Increase the length of the plug so that it is resting against the warhead.
